SNAG LIST

Mr Client
99 Any Street, Any town,
Dublin

PROPERTY INSPECTION DATE: /xx/01/20

TYPE: DEVELOPER:
4 bed – house

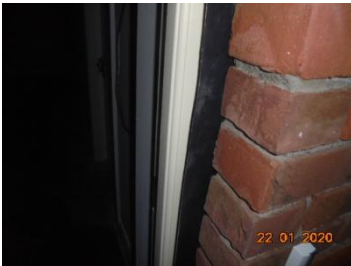
1. Front door – trim DPM and seal top rail of frame & r/h/s jamb to reveal with mastic.

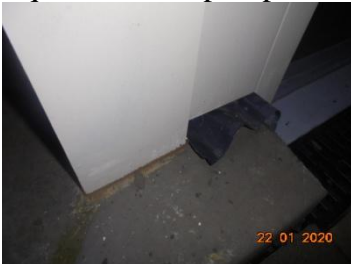
2. Front door - face of door leaf paint coat very poor blemished, patchy & marked. Paint required & repaint door sweep.
3. Front door corner column & l/h/s elevation window - trim DPM. Foot of column requires touch up of paint also.

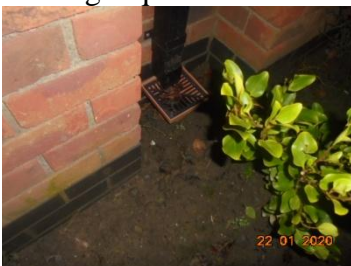
4. Front door l/h/s jamb / frame (side profile) - locking receiver plate bent / damaged. Door leaf not locking and
5. Drive bay - power wash and remove staining and paint on cobble bricks. Sand / gravel brushing required after cleaning completed.
6. Gully at down pipe at party wall 'alcove' - top of gully fitting proud of surrounding finished ground level of bedding - Seat gully to proper level. All landscaping at bedding requires attention also.

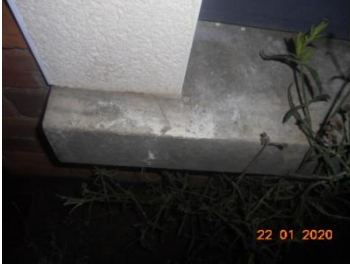
7. Ground floor window cill - clean / wire brush cill.

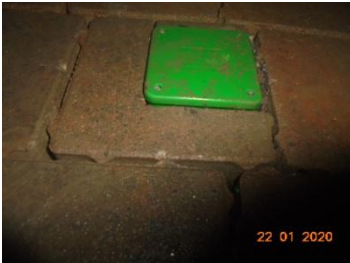
10. Earth rod box at paving - box uneven and proud. Ensure flush with surrounding cobble lock.

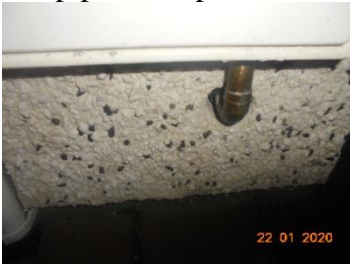
11. Gas pipe wall aperture - fill gap at surround to close up.

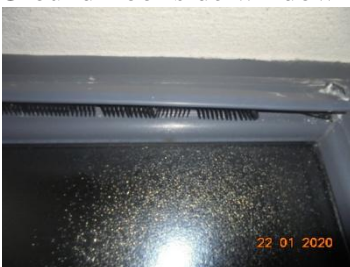
12. Close EIR / UPC doors and clean all meter box housings (GAS / ESB).
13. Ground floor side window - trickle vent damaged. Replace.

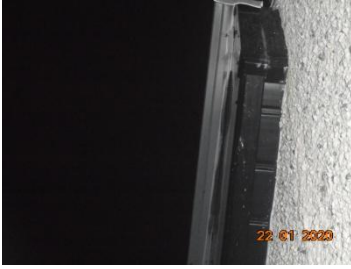
15. Rear lean to roof - top of verge over hang, poor coverage of lead flashing seal.

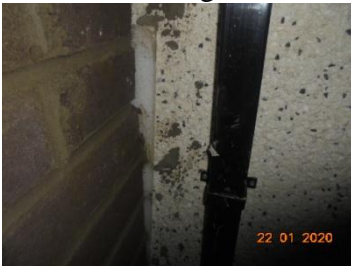
17. Rear 'lawn' area - complete landscaping & seeding. Further lawn after care to be provided after closing to ensure no patches in growth etc.
18. External tap located 2 ft off set to side of gully drain below sink window - poor design for surface water drainage at paving.
19. External double doors - clean paint and render from all door jambs, hinges (hinge caps) and door leaf stiles.
20. Down pipe to l/h/s of sink window - clean down pipe & remove all concrete scut from wall surrounding.

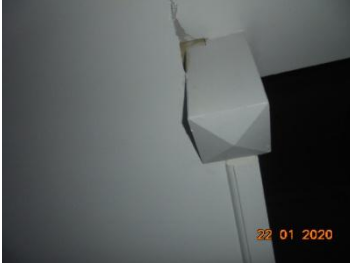
27. WC door leaf - rattling when shut. Adjust mortise rebate / striker plate.
28. Kitchen door leaf not closing into framing. Shave / adjust if timber doesn't acclimatise when heating engaged.
29. Ceiling above foot of stairwell - plaster work poor, rough & pitted.
30. Foot of newel post of 3rd flight of stairs (above 1st mid landing) - plaster work incomplete, skim tape showing. Plaster & paint required to make good.

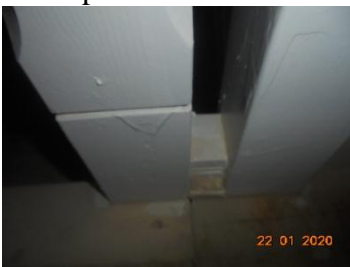
31. 1st mid landing at 1st stairwell - twin newel posts paint work poor at base of both newel post.

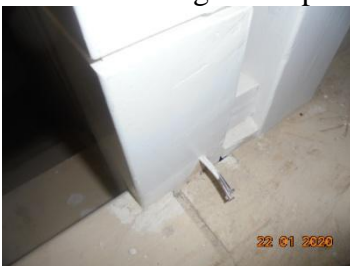
35. 1st floor landing newel posts - nails protruding at base of newels.

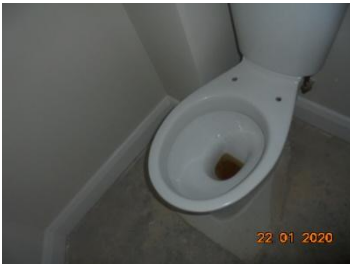
51. Door leaf self closer hinge arm - oil required.
52. Fit toilet seat.

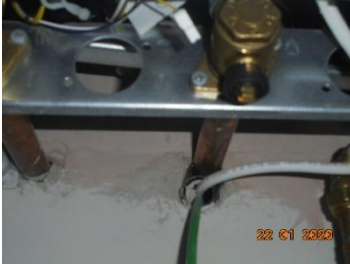
64. Velux window - top frame edge, paint required. Clean glass and ensure not scratched.
65. Wall surrounding double door opening - plaster rough, lumpy & pitted.
66. Double door top and both side reveals - angle bead showing through plaster work.
67. Double door framing, jambs & door leaf stiles cleaning required at all. Also door overlap & U channel at threshold.
68. Flooring at foot of double door opening - levelling compound required prior to finished floor application.
69. Boiler to be commissioned. Cross bonding / equipotential bonding required at copper pipe work below appliance.

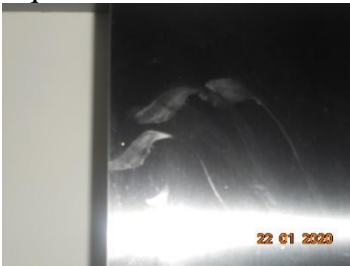
70. Wall surrounding sink window opening - plaster rough, lumpy & pitted.
71. Sink window top and both side reveals - angle bead showing through plaster work.
72. Sink window - clean all framing and jambs.
73. Sink - tap loose
74. Sink unit below counter - fit shelving.
75. Below counter door leaf to l/h/sink - paint stained, clean.
76. Extract hood - 1. Duct casing above hood damaged / scratched. 2. Wall surrounding hood, paint required at gaps.
77. Top drawer - paint mark on face.
78. Wall finish to r/h/s of hob splash back - plaster work rough, filler, sanding & paint required.

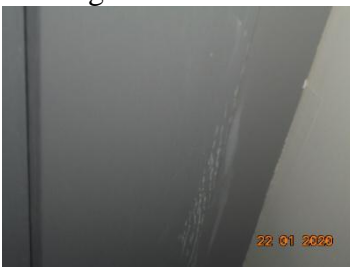
79. Isolation switch plates & electrical plates at over counter position - chipped & marked at surround. Filler and paint required.
80. Fridge & freezer door paint marked. Check all fitted kitchen doors for stains and paint marking & clean.

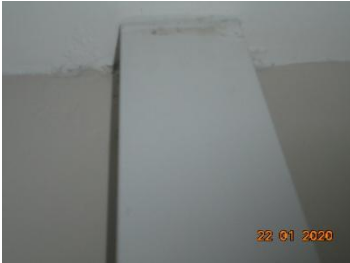
83. Wall / ceiling above ESB board at cable boxing - poor plaster and paint finish. Filler & touch up of paint required.

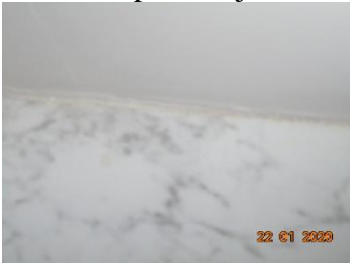
84. Counter top / wall join - large uneven gaps. Close up with caulking.

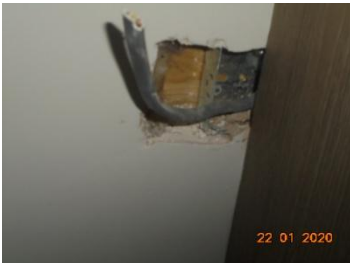
86. Below counter level - 2.5 twin & earth cable tail exposed at back box.

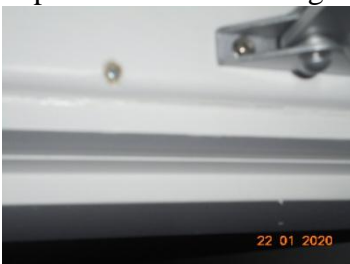
89. Top architrave of landing door - filler required at screw holes.

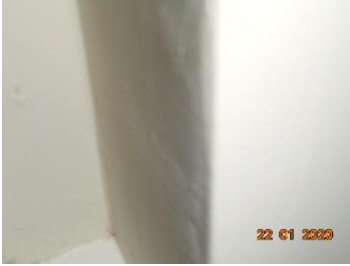
92. Wall surrounding window opening - plaster rough, lumpy & pitted.

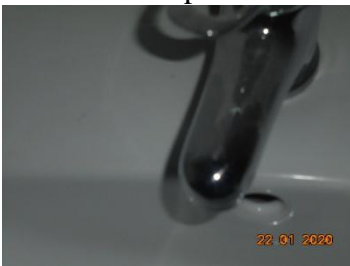
96. Wall surrounding awning window opening - plaster rough, lumpy & pitted.
97. Window top and both side reveals - angle bead showing through plaster work.
98. Window - 1. Clean all framing, jambs & opening framing, 2. Window handle scratched & tarnished - replace.
99. Sink bowl - movement at bowl, ensure securely mounted to wall.
100. Sink splash back / bowl join - silicone required at joint gap.
101. Sink tap loose - secure.

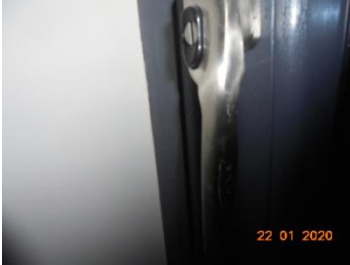
- 109. Sink tap loose - secure. Also stopper not fitted.
- 110. Window - 1. Clean all framing, jambs & opening framing, 2. Window handle marked & tarnished.

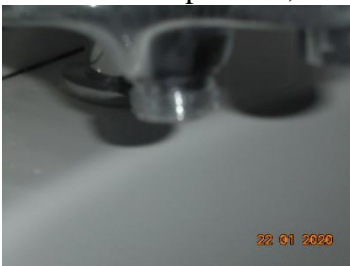
- 111. Bath tap - hose, head & holder required.

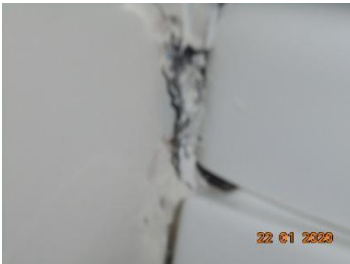
- 112. Clean down all wall tile edge band.
- 113. Head & foot of bath - silicone & paint required to tidy

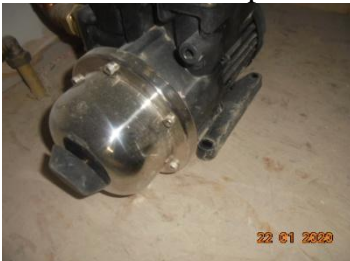
- 117. Circulation pump - mounted directly to sub floor increasing impact noise transfer. Insulation packer / rubber mount required.

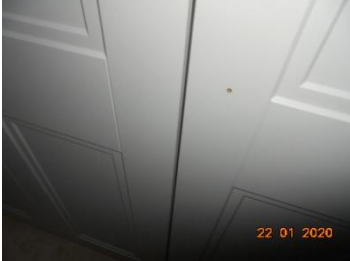
121. R/h/s robe door leaf - handle missing.

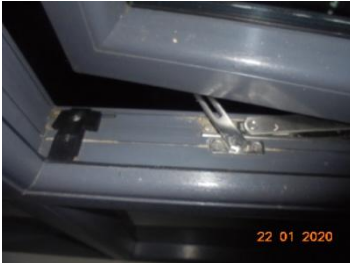
122. Window - r/h/s casement opening - safety catch jamming.

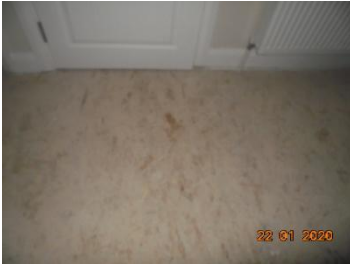
128. Flooring at door to landing - movement & squeak under foot. Further fixing required.

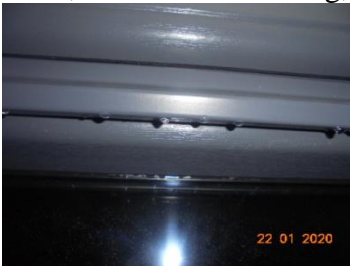
129. Party wall double socket loose - secure & caulk where proud at surround.
130. Dormer Twin casement window - 1. R/h/s opening trickle vent - trapping water, 2. Clean all framing, jambs & opening framing.

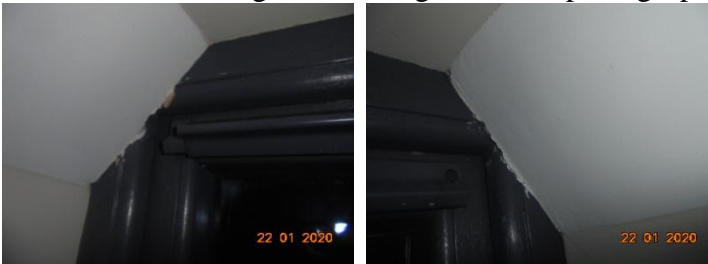
131. Wall / ceiling surrounding window opening - plaster rough, lumpy & pitted.

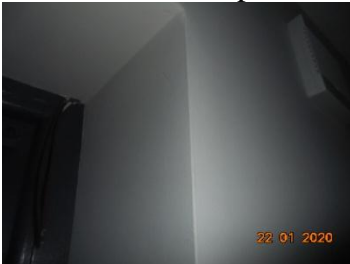
135. Window top and both side reveals - angle bead showing through plaster work.

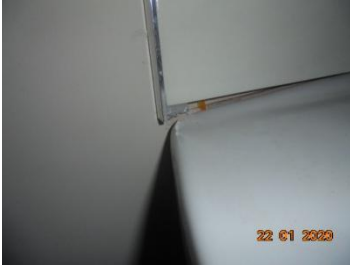
138. Sink / splash back joint - silicone required at join.

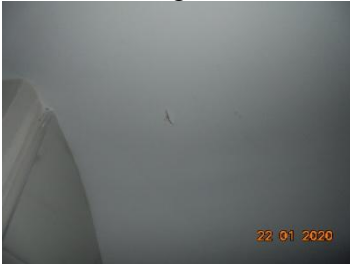
139. Clean all sanitary wear.
140. Clean all wall tile edge band and tiles.
141. Clean shower waste trap & tray.
142. Shower tray / wall tile joint - silicone bead required at all sides to seal.
143. Ceiling above shower area - paint peeling, touch up / repaint as required.
